60-7-106

SUBJECT: "Intercycle Evaporator Explosion, Building 3019," and
"Decontamination of Building 3019." - Papers Presented
at a Chemical Technology Division Seminar, July 19, 1960

INTERCYCLE EVAPORATOR EXPLOSION, BUILDING 3019

DECONTAMINATION OF BUILDING 3019

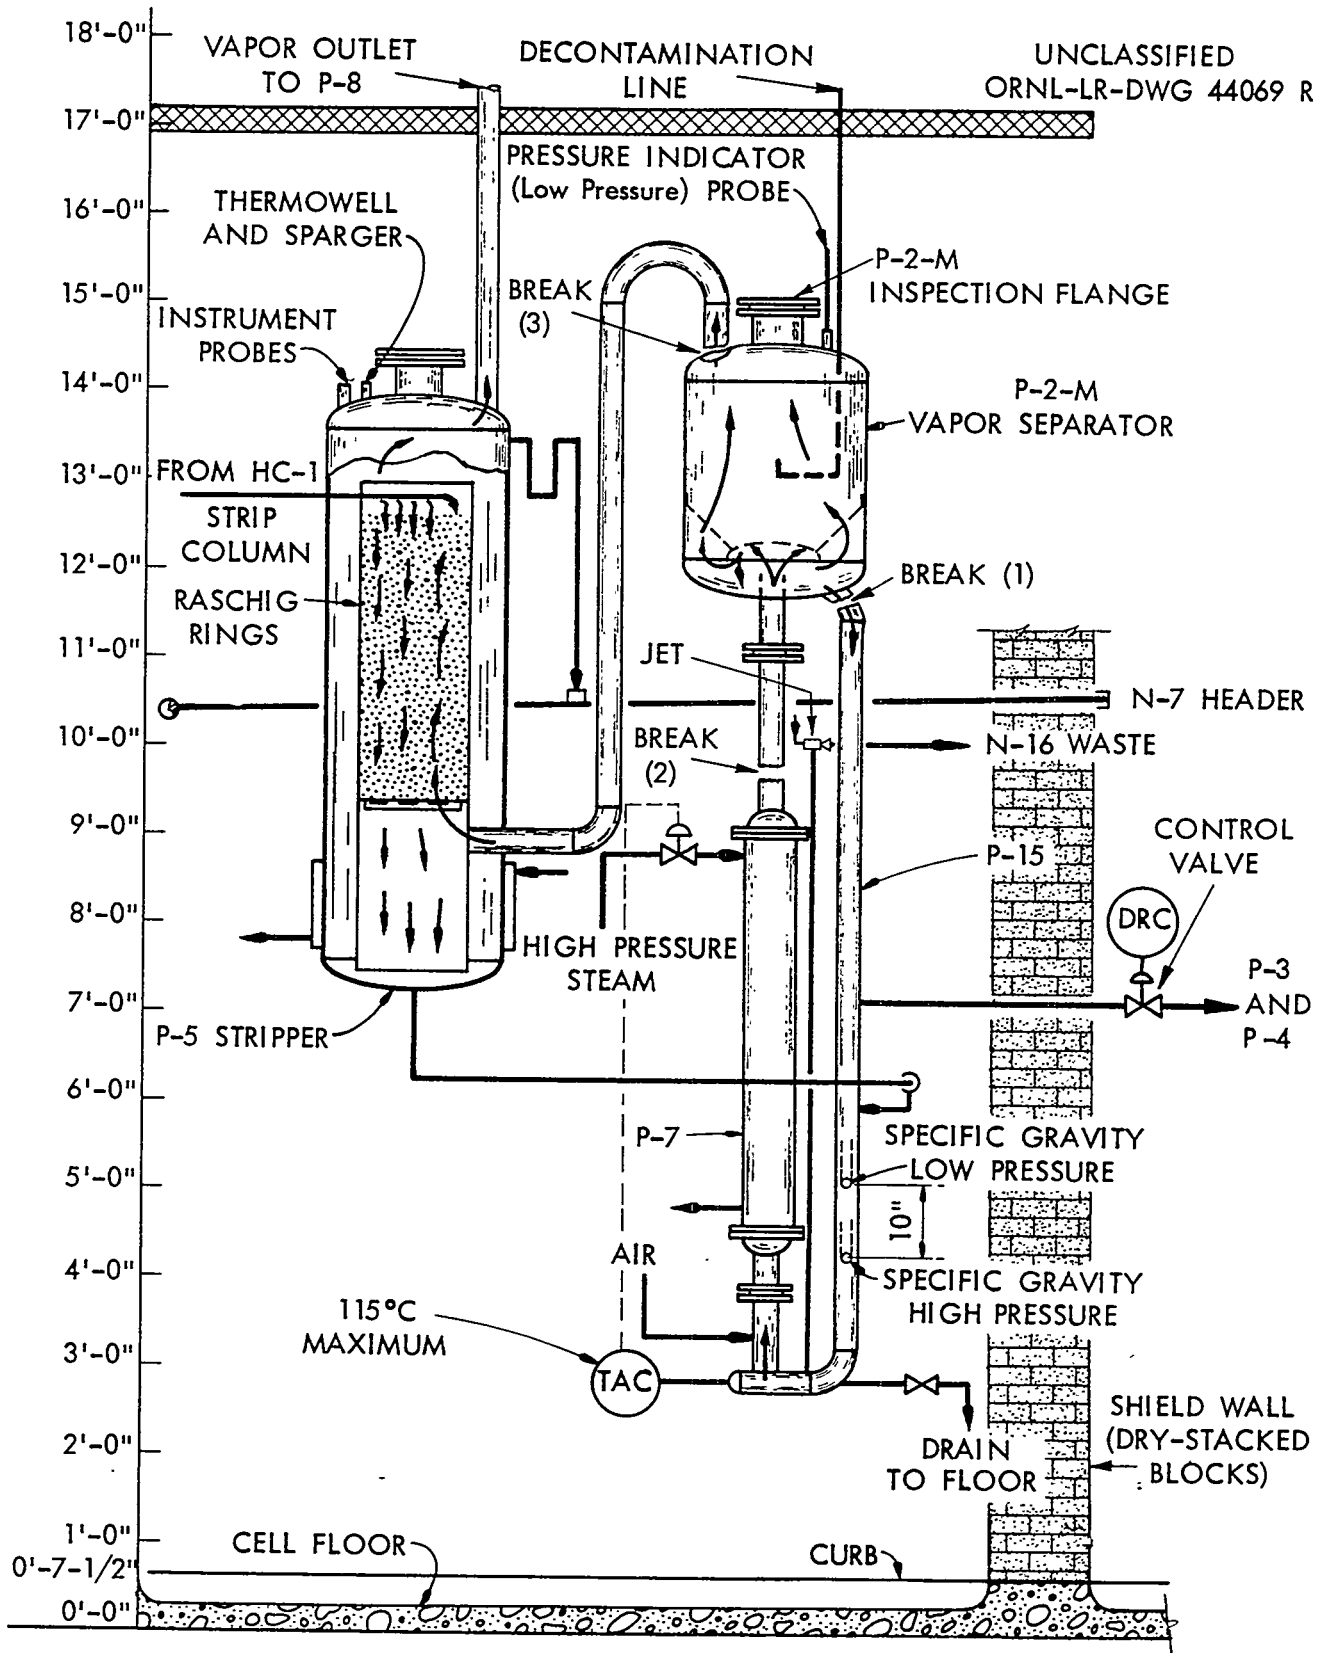
Fig. 2.

The aqueous stream from each of the strip columns is fed to one of two inter-cycle evaporators where it is concentrated and collected in catch tanks for transfer to Metal Recovery for further processing. The evaporator which exploded was one of the two intercycle evaporators. Figure 2 is a drawing of the evaporator loop.

P-15 EVAPORATOR
